## CONSTRUCTION GENERAL PERMIT SITE INSPECTION REPORT - LEVEL 1 (FOCUSED)

<b>Project Name:</b>	Radford University New Academic Building		<b>Permit Number:</b>	VAR10D473
<b>Project Address:</b>	E Main St		<b>County/City:</b>	Radford (RU Campus)
<b>Project Operator:</b>	Radford University		<b>Operator Telephone:</b>	(540) 831-7810
<b>Project Contact:</b>	Guy Rhodes		<b>Contact Telephone:</b>	
<b>Contact E-Mail:</b>	<a href="mailto:grhodes2@radford.edu">grhodes2@radford.edu</a>		<b>Qualified Personnel (QP):</b>	Not reviewed
<b>Inspector:</b>	D. Packard		<b>Weather (Wet/Dry/Rain):</b>	Dry, 90s
<b>Total Dist. Acres Permitted:</b>	3.30 Ac	<b>Est. Dist. Acres (At time of inspection):</b>	0 Ac	<b>Inspection Date &amp; Time:</b>
<b>Linear Project:</b> <input type="checkbox"/> Yes <input checked="" type="checkbox"/> No <b>Annual Stands. &amp; Specs:</b> <input type="checkbox"/> Yes <input checked="" type="checkbox"/> No <b>VSMP Authority:</b> <input type="checkbox"/> Locality <input checked="" type="checkbox"/> DEQ

## CONSTRUCTION GENERAL PERMIT SITE INSPECTION PHOTO LOG

**Project Name:** Radford University New Academic Facility

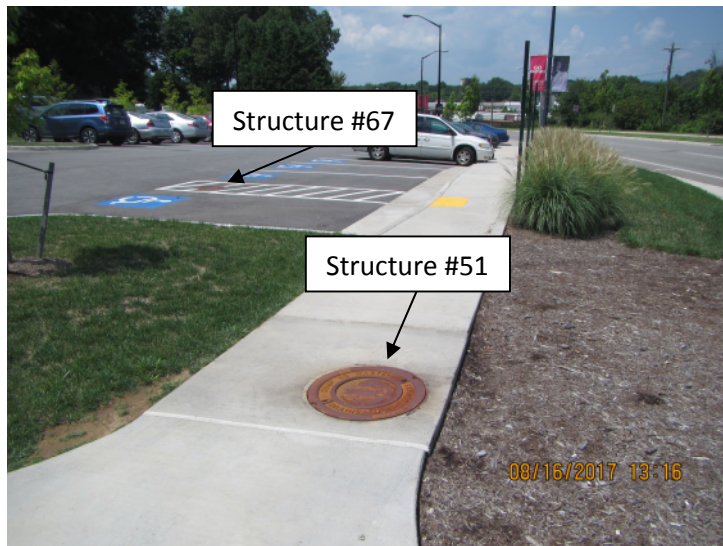
Fig. 1

Description: Parking lot "GG", viewed facing west. The stormwater collected from the site enters the underground detention system at structures #51 and #67.

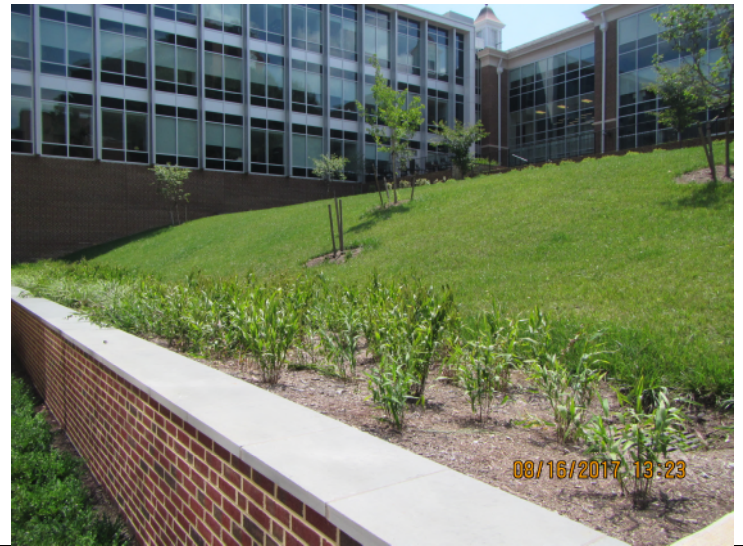
Fig. 2

Description: The courtyard area, viewed facing south.

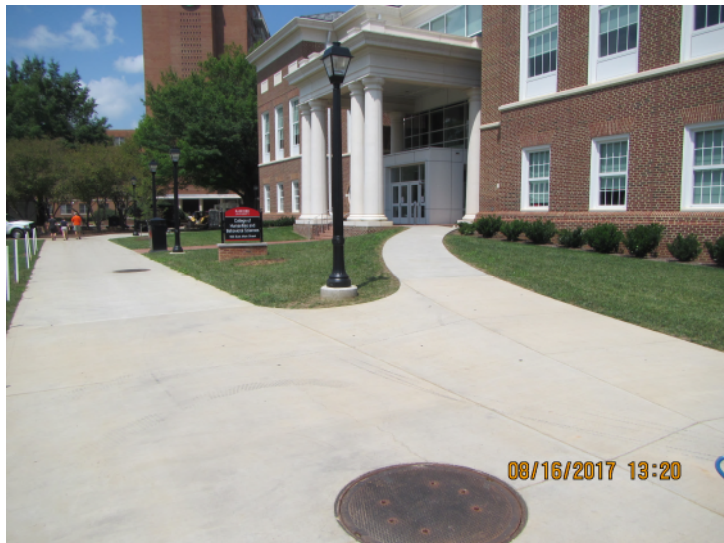
Fig. 3

Description: South entrance to the New Academic Building (College of Humanities and Behavioral Sciences), viewed facing northwest.

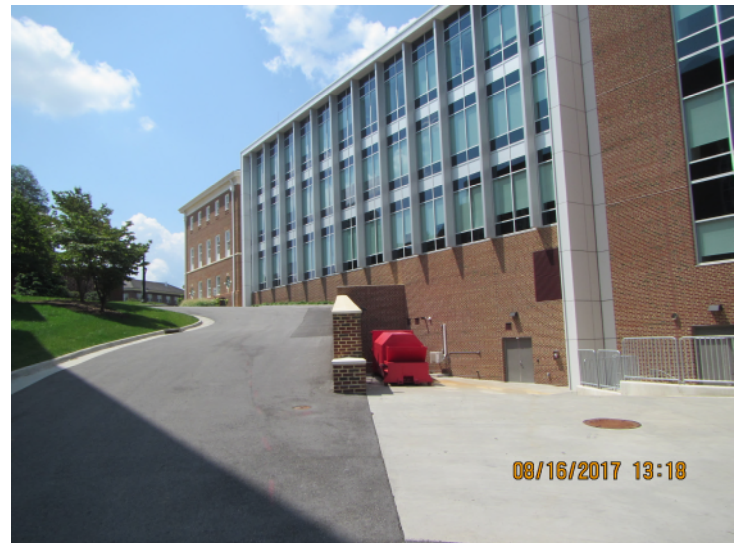
Fig. 4

Description: East side of the New Academic Building viewed facing southwest.
