RADFORD UNIVERSITY

BMP INSPECTION REPORT

Project Number: 2429.3

Date: July 26, 2017

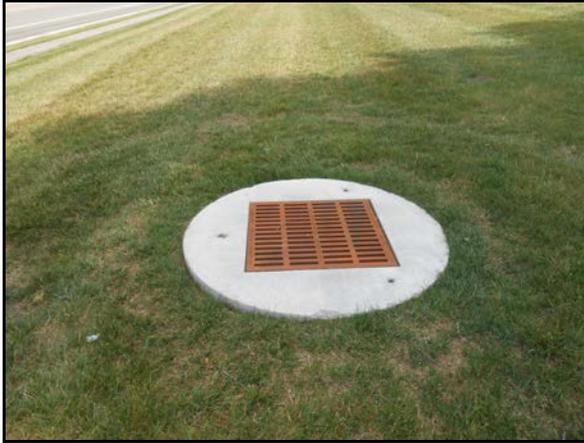
RU-BMP-IF-1 – UNDERGROUND STORAGE

- Small bits of sediment in sections. Sediment has not reached the 5% range. Recommend cleaning once the 5% level has been reached.

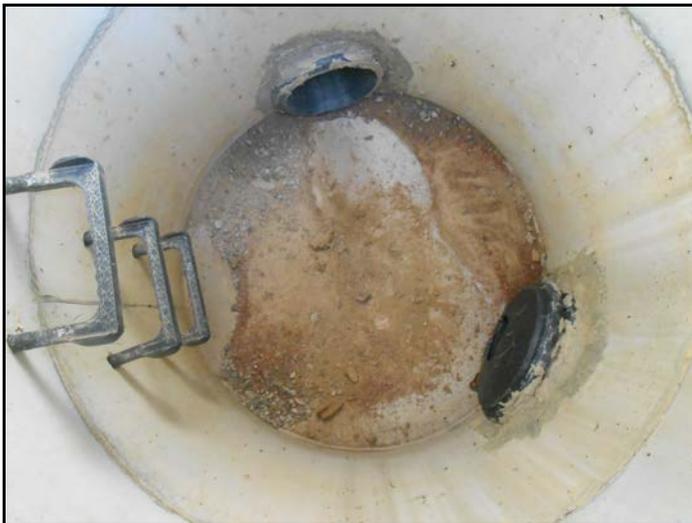
RU-BMP-HF-1 – UNDERGROUND STORAGE

- Small bits of sediment in sections. Sediment has not reached the 5% range. Recommend cleaning once the 5% level has been reached.

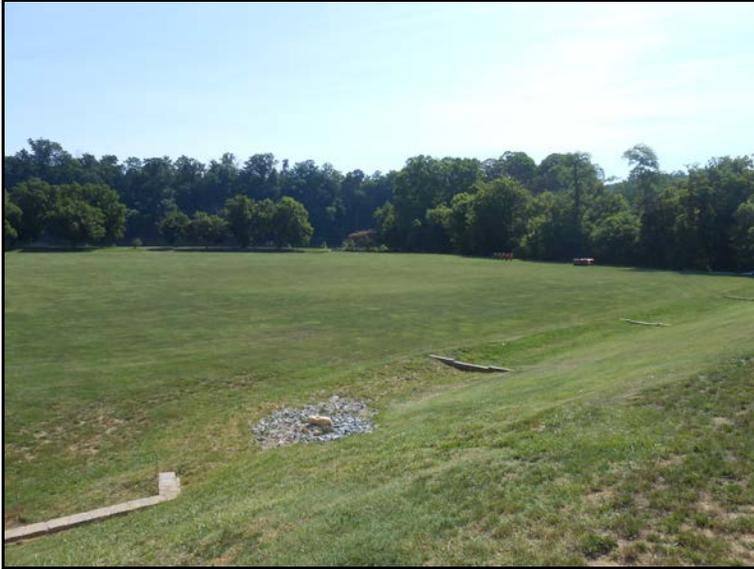
RU-BMP-HF-1 – GRASSED SWALE

- Riprap has been added to the outfall of the underground detention prior to entrance into the grass swale.

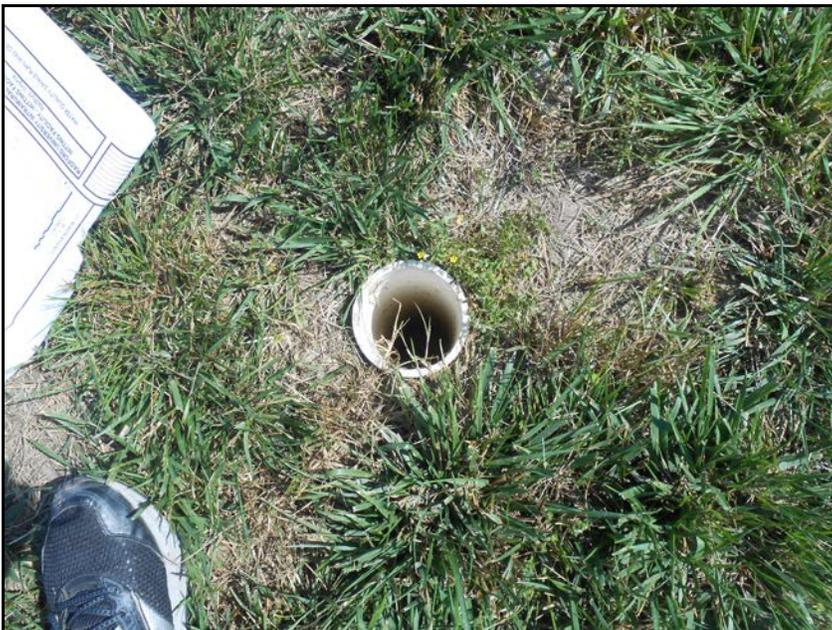
- Check cleanout tops & missing covers. Check required screening to keep animals out of the drain system. Some areas of the grass swale have been compacted due to heavy equipment being driven over the BMP. Larger mowing equipment should be avoided in this area.

1. Check cleanout tops & cover (some exposed) requires screening from animals & repair from extendable drain pipe.
2. Some areas are compacted due to heavy equipment on swale. RU Staff advised to avoid heavy mowing equipment in swale area to avoid compaction of soil mixture.

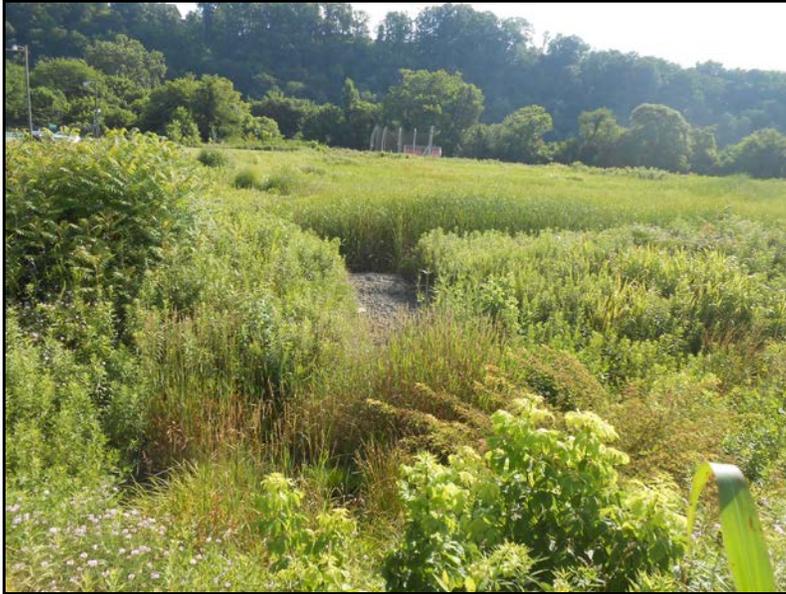
RU-BMP-WT-1 – CONSTRUCTED WETLANDS

- The pretreatment (forebay) requires removal of vegetation as well as location of the 50% marker to measure the amount of sediment buildout in the facility. Parts of the gravel access road can be seen but the remaining sections are covered in vegetation.

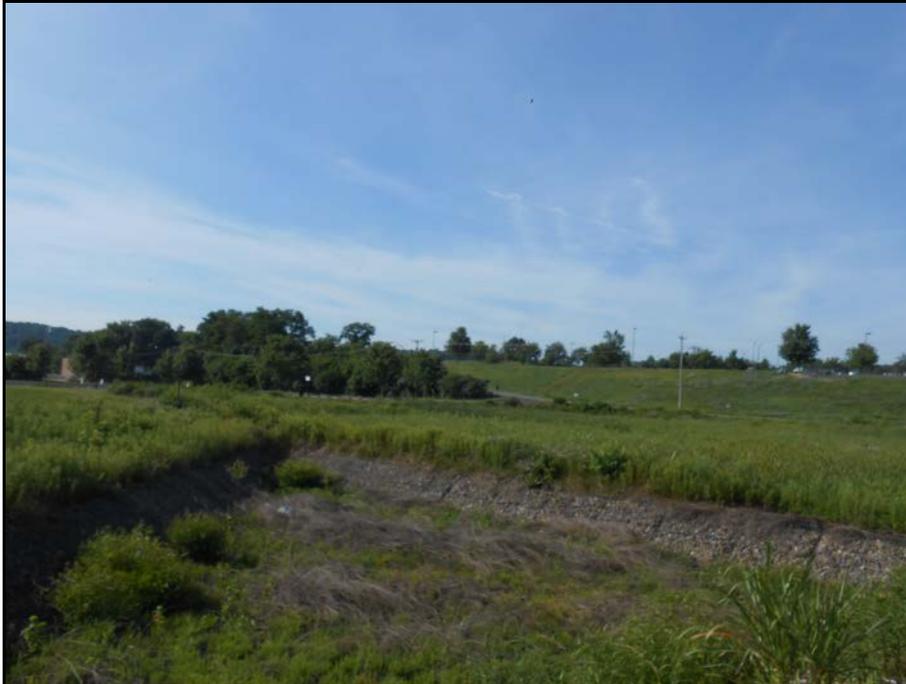
- Excess vegetation should be removed to allow access to the various cells within the wetlands as well as the outfall and emergency spillway areas. Based upon the 2016 report, invasive species were identified in the wetland cells. The original plan has a schedule for the high and low mashes. Currently there are cattails and phragmites within the wetland area. Control of those invasive species should be implemented if they reach 15% of the wetland cell.

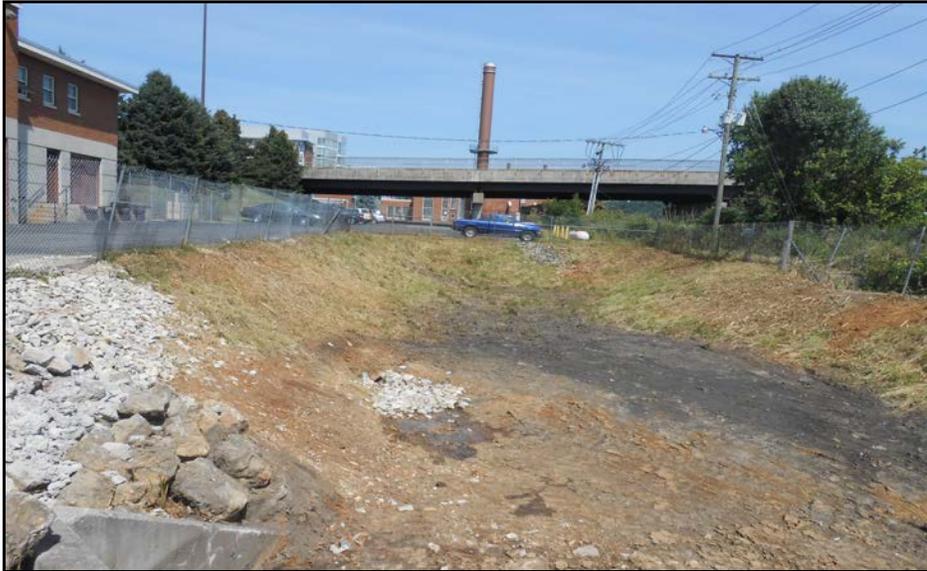
RU-BMP-AL-1 – DETENTION POND

- Trash, debris, and excessive vegetation removed. Riprap placed alongside slopes to protect areas identified in the 2016 report. At the time of this investigation, the seeding had not been completed. The University will reseed the pond to stabilize the facility.

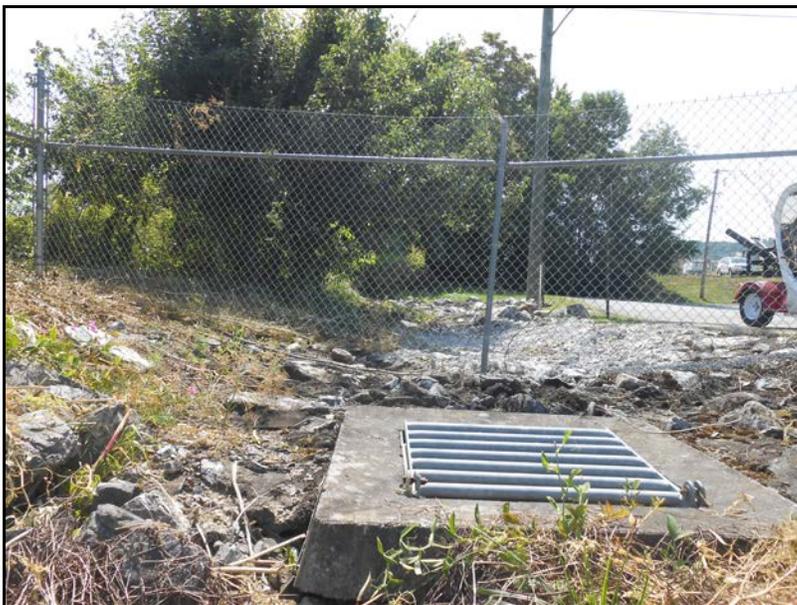
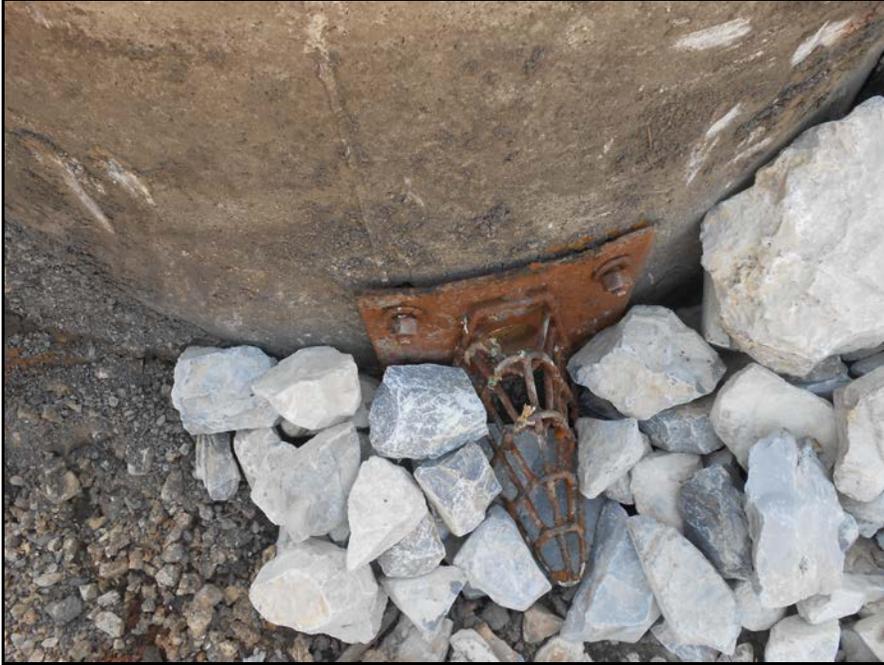
- Sediment removed from riser structure and clean riprap placed around lower orifice. Pond functions restored. Excess concrete in spillway removed.

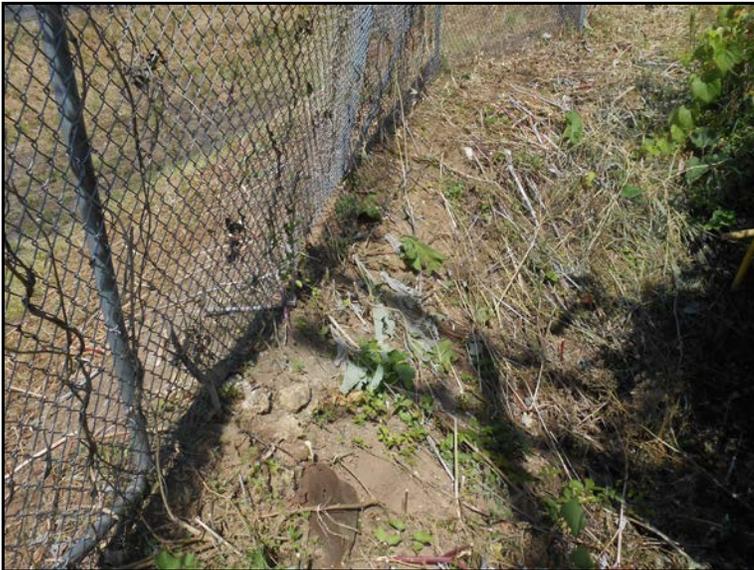
- Once vegetation had been removed, it was noted that the berm area near a gas line installation shows a potential compromise to the berm structure due to cutting into the lower part of the berm during the installation of the gas line. Berm structure is intact but does not have full width. Recommend placement of fill in section to widen berm.

Fences and/or safety signage is inadequate		X		Repair fences and signage for public safety.
	Trash in the pool		X		Remove immediately and observe safety procedures.
	Additional notes: <ul style="list-style-type: none"> • Side slopes – reseed. • Vegetation removed. • Sediment removed. RU Staff to reseed pond area. • Noted that area where gas line access is located has the potential to compromise the embankment. RU Staff to investigate alternatives to monitor berm.

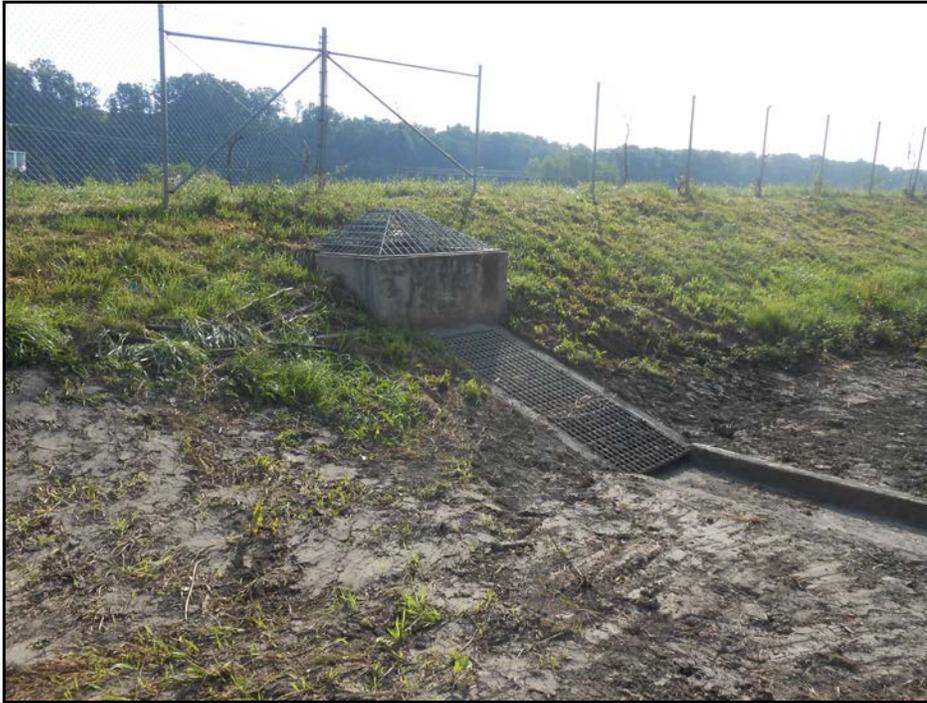
RU-BMP-AR-1 – DETENTION POND

- Trash, debris, and excessive vegetation removed. At the time of this investigation, no seeding had been done. University to seed the pond area for final stabilization of the BMP.

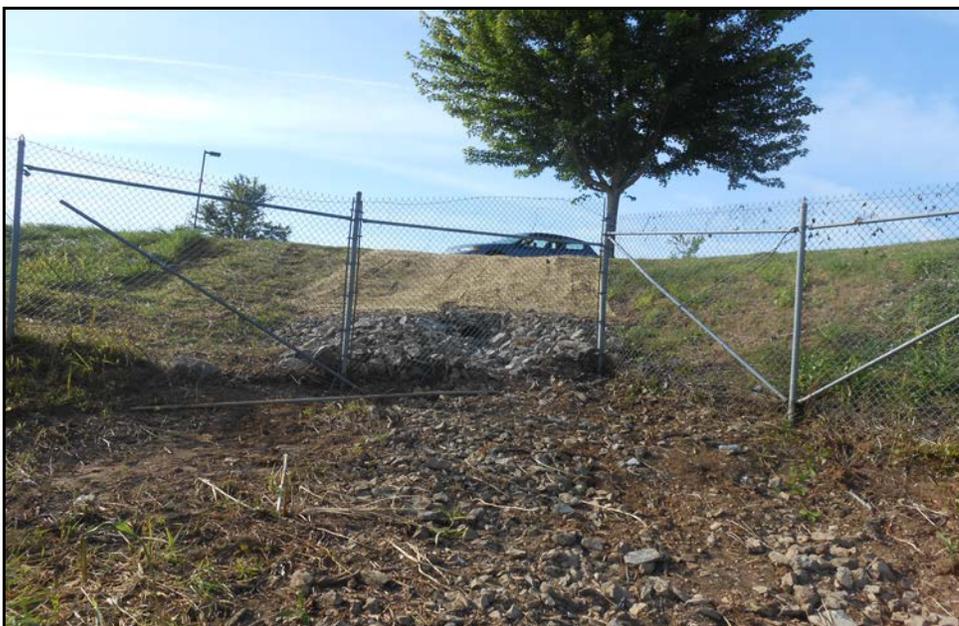
- Restoration of side slopes, pipe replacement and fill material to protect areas identified in the 2016 report.

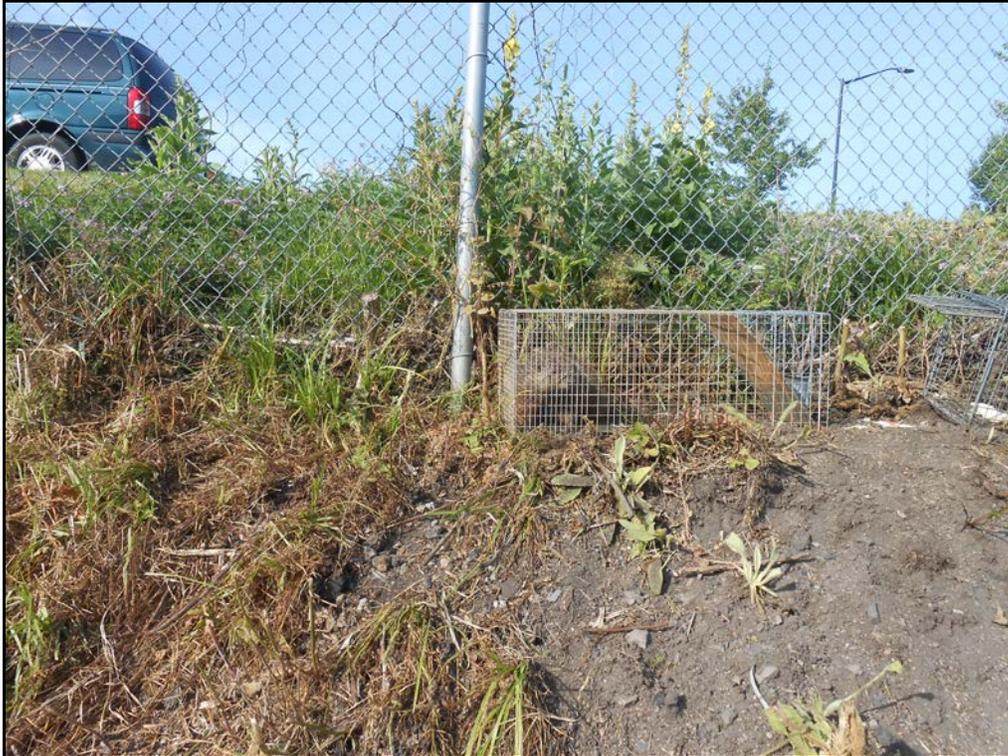
- During the inspection it was noted that the maintenance road into the site was depressed. The University should maintain the access road but make sure that the depression does not lower in elevation to compromise the pond volume or function. In addition, traps have been set for nuisance animals to protect the berm from being compromised.

Fences and/or safety signage is inadequate		X		Repair fences and signage for public safety.
	Trash in the pool		X		Remove immediately and observe safety procedures.
	Additional notes: <ul style="list-style-type: none"> • Traps set to capture groundhogs and other vermin. • Area cleaned of vegetation and sediment. • Currently not seeded at time of inspection. RU Staff to seed and stabilize. • Inlet pipes repaired. • Maintenance road is depressed. RU Staff notified to make sure berm is not compromised.

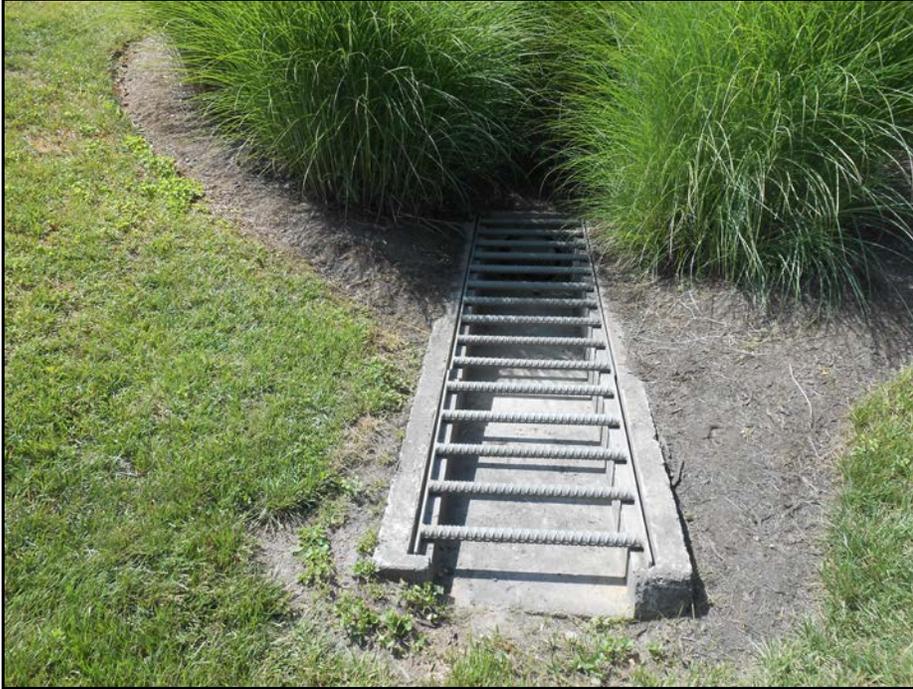
RU-BMP-CH-1 – DETENTION POND

- Trash and debris was removed from the inlet structure and minors repairs completed. Overall, the facility has been kept in good condition.

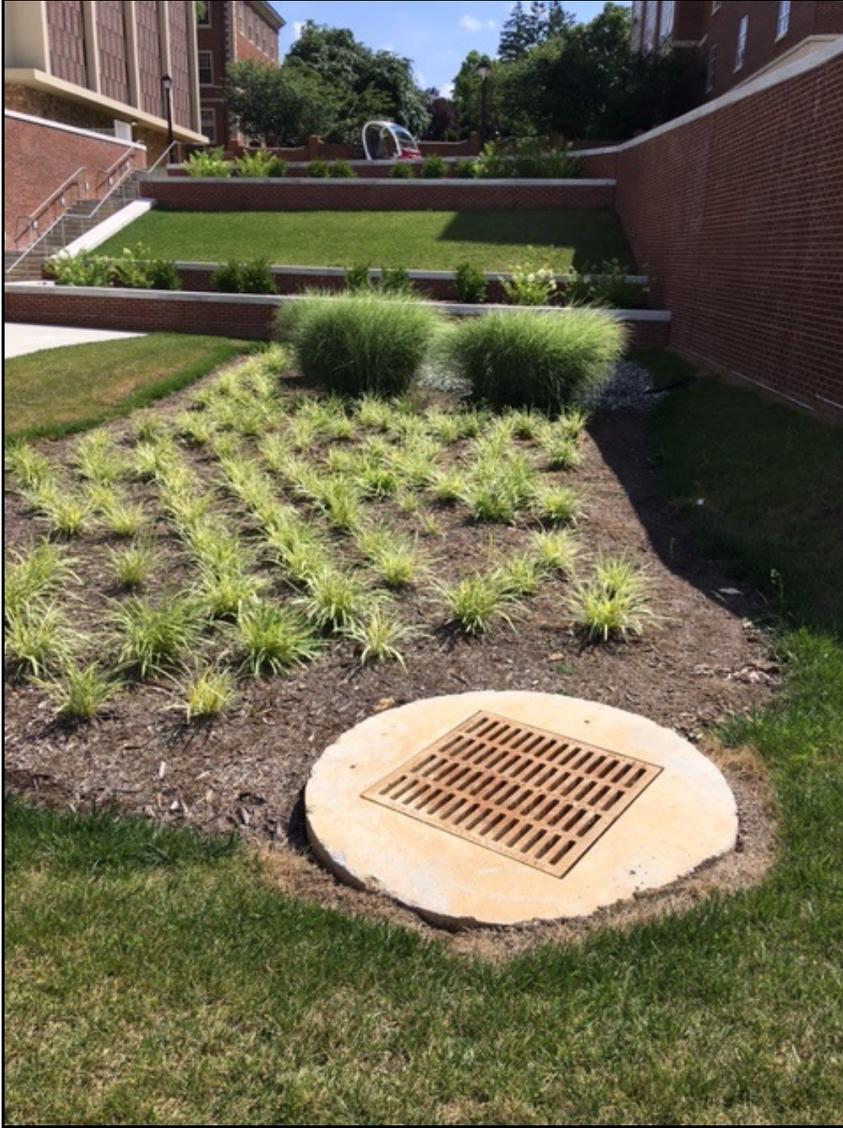
RU-BMP-SC-1 – BIORETENTION

- The BMP is a relatively new facility with no apparent trash or debris from drainage area. Plants and mulch have been maintained. No issues with the underdrain or media.

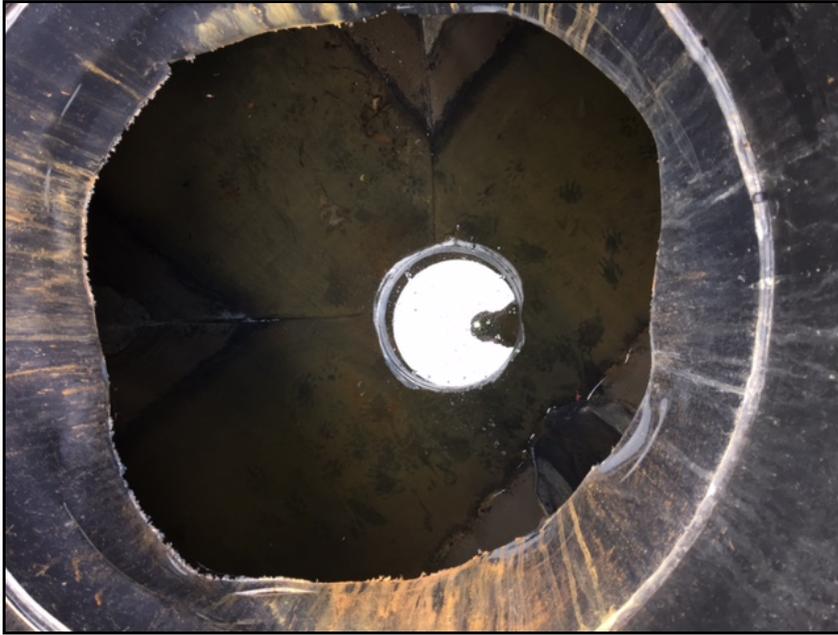
RU-BMP-HU-1 – UNDERGROUND DETENTION

- Small bits of sediment in structure, however, less than 1%. Removal of sediment is required once 5% has been reached to ensure proper function of detention system. It was noted that the Humanities Building HVAC units send condensation water to the facility. Overall the system is new and in good condition but the amount of condensation water should be monitored.

1. Drains from the roof sending condensation water to the system. 2. Overall good condition.		
Wet weather inspection needed <input type="checkbox"/> Yes <input checked="" type="checkbox"/> No
